# An Innovative Water Cut-off Solution for a Hard Rock Tunnel

By Vreneli Wall, Marketing Co-ordinator, Multiurethanes Ltd.

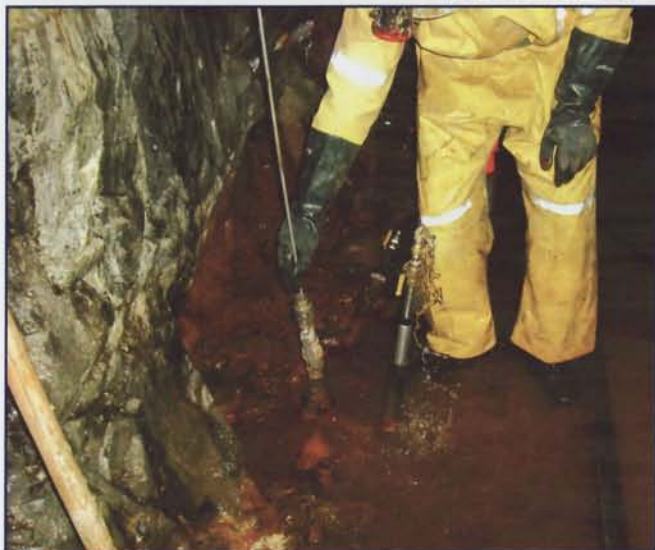
Experienced grouting technicians work together to stop the most difficult water flows.

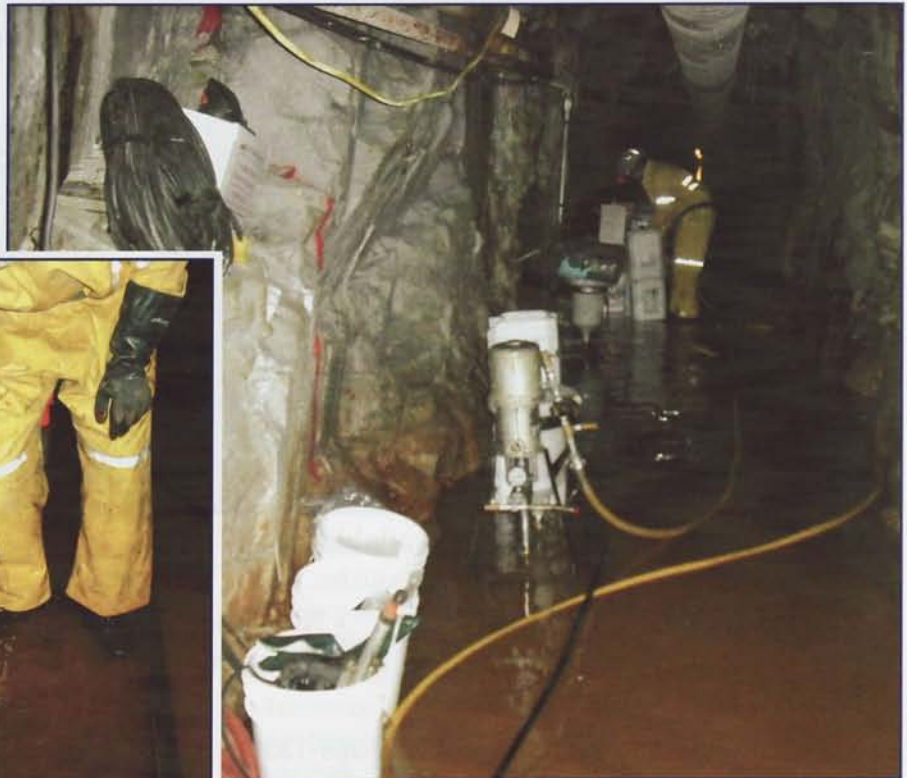
From high volume flowing water to a dry tunnel. Call Multiurethanes when difficult ground conditions are experienced on your jobsite.

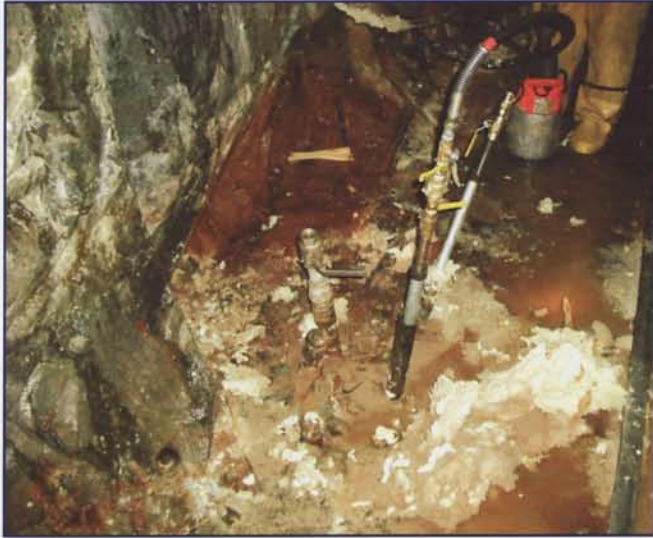
Grout plugs are installed to allow high pressure injection of Multiurethanes Universal Resin.
