Mine Grouting Expertise

Troubleshooting

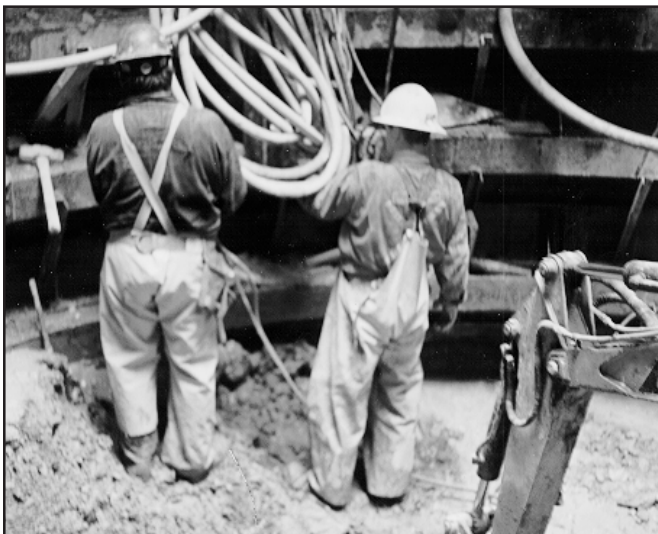
Miners preparing for polyurethane injection to stop inflows of quicksand into a 24 foot diameter shaft collar excavation

* supervised grouting operations to overcome quicksand conditions during sinking of 24 foot diameter caisson through 60 feet of plastic clays and water-bearing sand formations

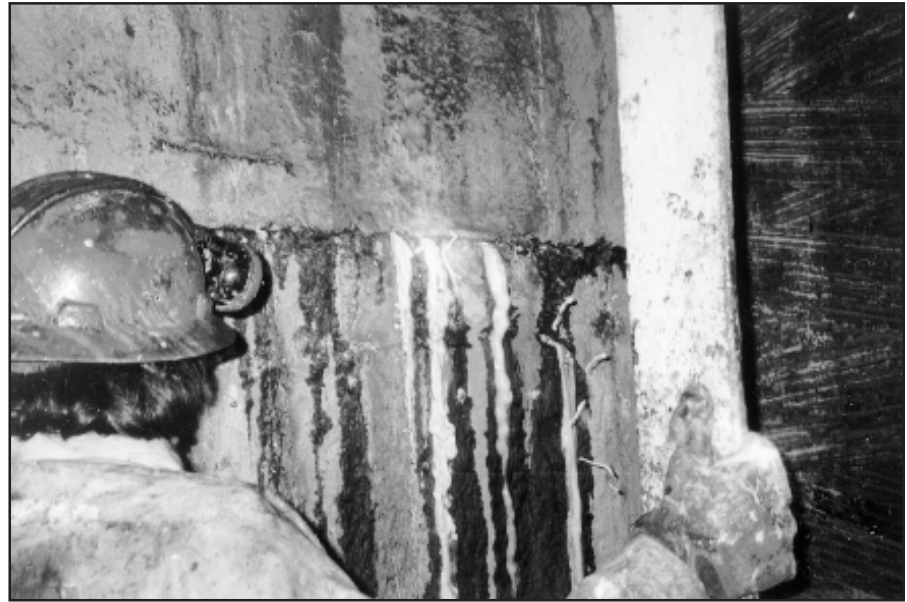
Water-activated polyurethane foam used to stop water inflows through leaking concrete construction joints in underground mine shaft lining using UNIVERSAL resin
